Lunker Federal #2-33-4H

Weekly Inspection Report

April 1 and April 4, 2013

Prepared for:

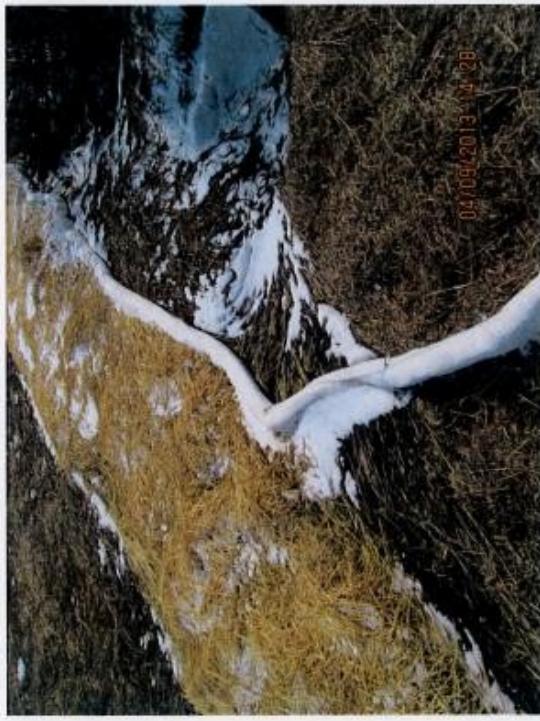
Figure 4. Standing water below west sorbent booms and hay filter strips on Wildlife Management Area.

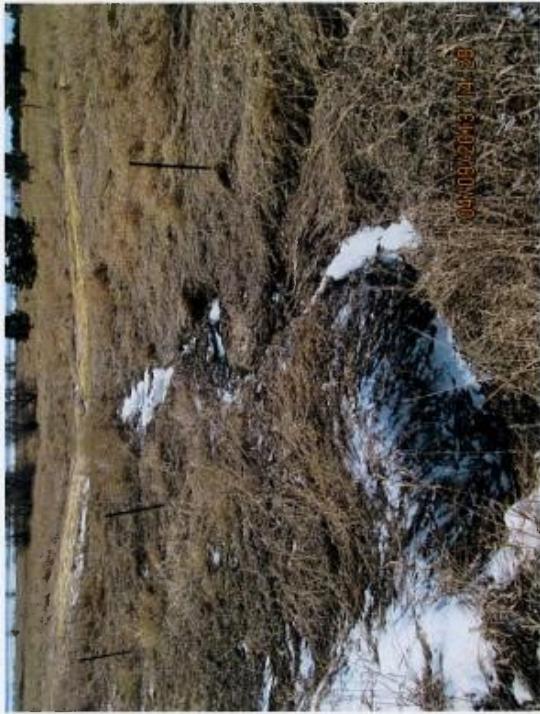
Due to prevailing weather conditions, Figure 5 shows sorbent booms which are submerged due to being frozen to the ground. During the time of the inspection, the ice holding the booms down melted, and the booms began to float on the surface of the water.

Figure 5. West drainage on Wildlife Management Area showing sorbent booms and hay filter strips.

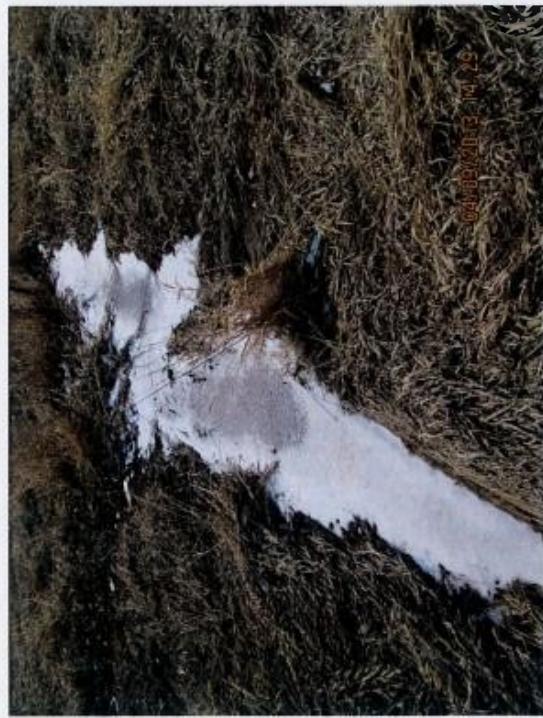
Figure 6. Standing water and ice above west sorbent booms and hay filter.

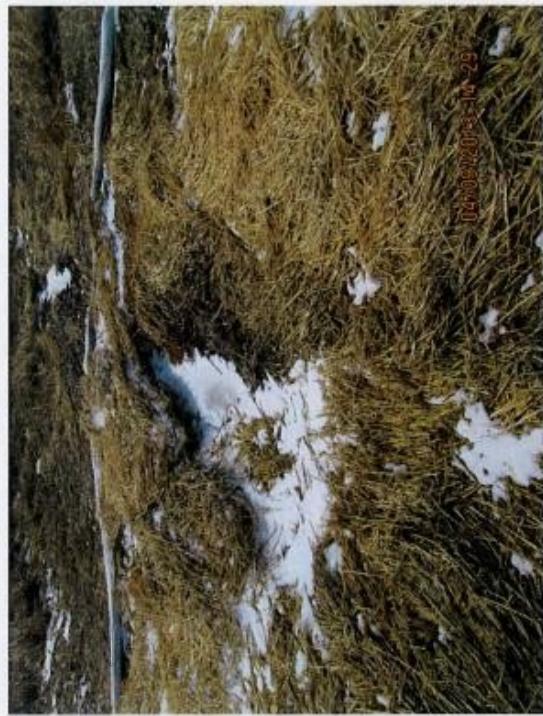
Arrived at Lunker at 1035 hours. The inspection began near at the northeast corner of the pad, and continued toward the lake. The area near the pad culvert was inspected. No signs of a sheen or floating oil and grease were observed.

Figure 7. Pad culvert.

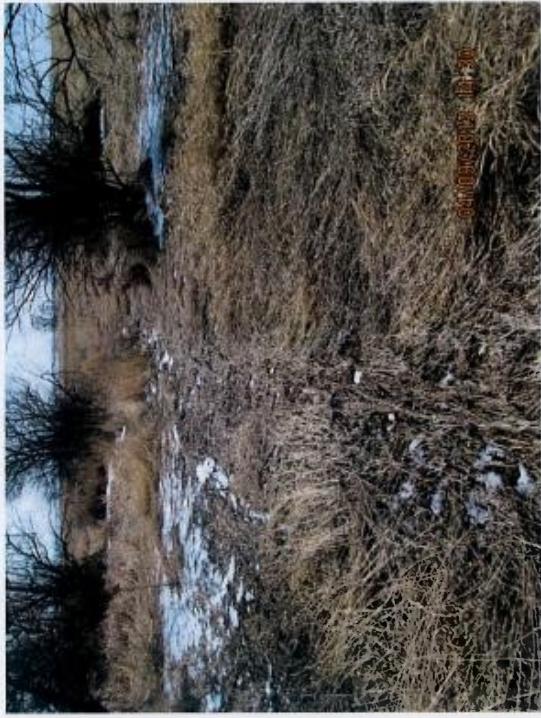
Figure 11. Standing water alongside hay filter.

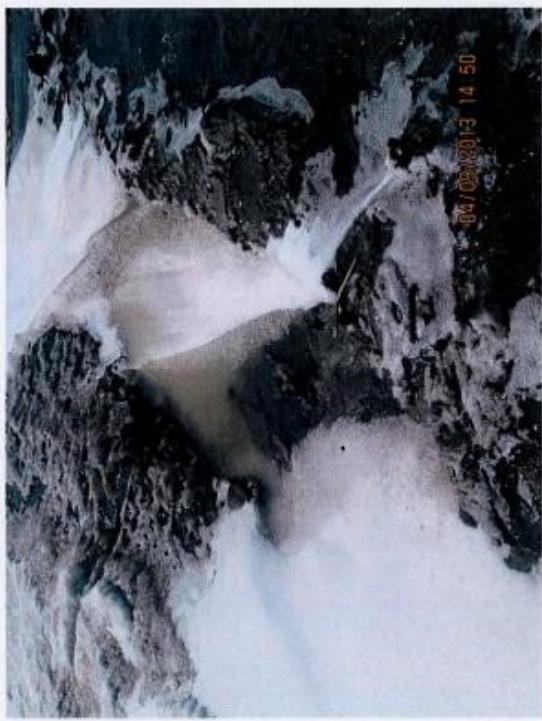
Figure 13

Figure 13. Culver out flow between Sections 32 and 33.

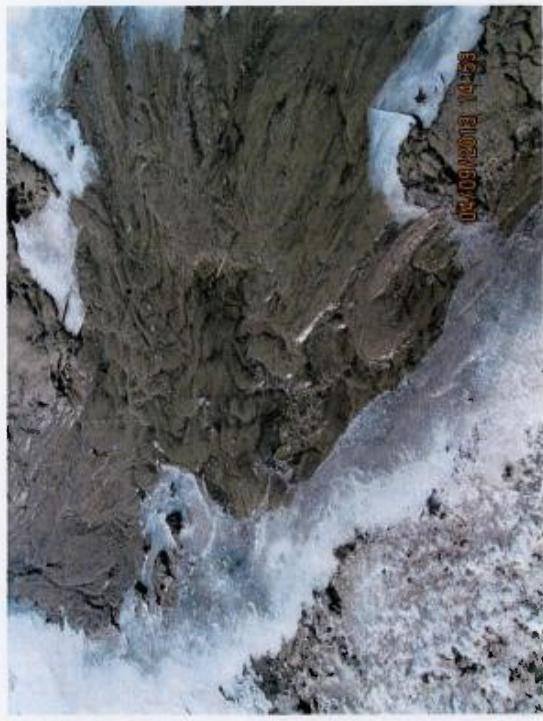
Figure 18. View of west booms and hay filter from a second perspective.

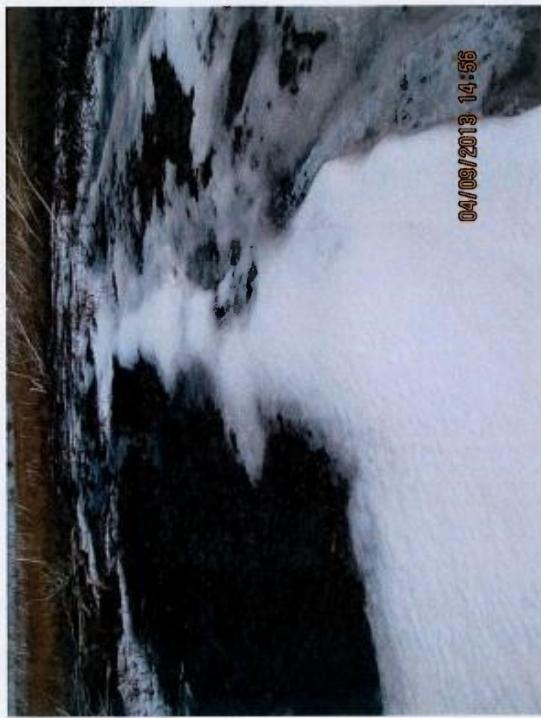
Figure 19. Flow of water through west hay filter strip.

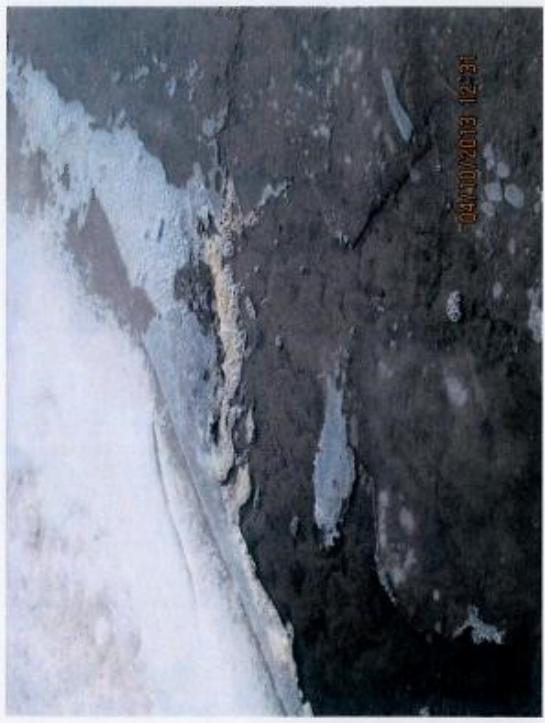
Figure 55.

Biological mass was observed north and east of the pad (Figures 55 and 56).

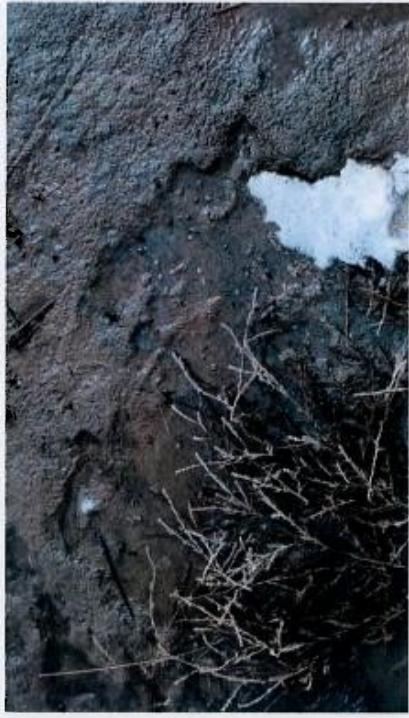
Figure 93.

At the east shoreline of the isolated pond, a sheen was noted by William Harlon. Mr. Harlon stated it resembled the sheen he had noted in his April 8th field report. The sheen is recorded in Figures 93 and 94.
